historic structure report

units 2, 3, and 4 volume 4 part 3 DEPOSITORY ITEM

ELLIS ISLAND

HISTORIC STRUCTURES REPORT UNITS 2, 3 AND 4

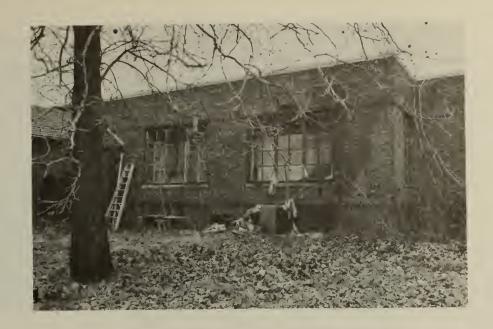
1. East facade, north of covered way 7B.

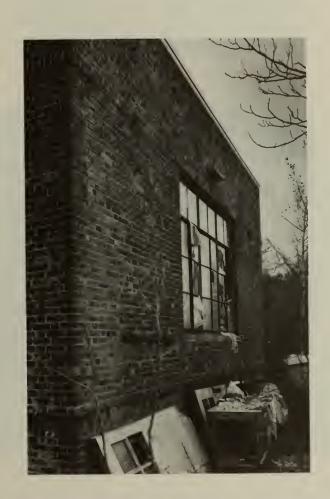
2. West facade, north wing.

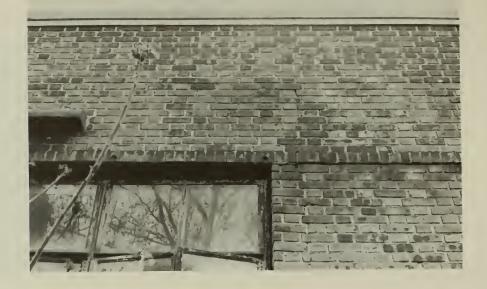
the original design, octagonal In conical roofed sunporches with decorative roof finials, and a second story with repetitions of brick and terra cotta coursing provided a strong decorative element. As built, the building is relatively simple in volume, materials and ornamentation. exterior walls are faced with a red 7-7/8" x 2-1/4" brick and are laid in Flemish bond over a common bond foundation, using a variable 5/8" gray mortar containing a small 1/16" aggregate. A water table of soldier brick and a string course of brick headers at the level of the window lintels provide the building's primary ornamentation (photos 1 and 2). Window sills and roof coping are of light buff terra cotta laid in a 1/4" orange-rust mortar. terra cotta roof coping has been faced with a flat band of copper flashing which extends approximately 4" over the brick wall surface on all elevations (photo 3).

The copper flashing which protects the terra cotta roof coping is torn and missing in some areas with two small areas of flashing on the roof face of the parapet also missing. Composition roof surfaces are in fair condition with bubbling along the seams of the roofing felt and water accumulation in the southeast corner of the south wing. The chimney located in the southern portion of the roof area of the central block has been coated with tar.

3. Terra cotta roof coping with copper flashing.

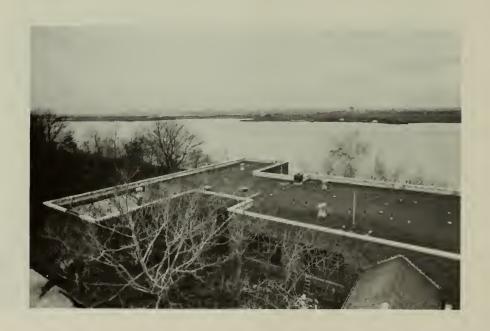
8. Roof, southern half.

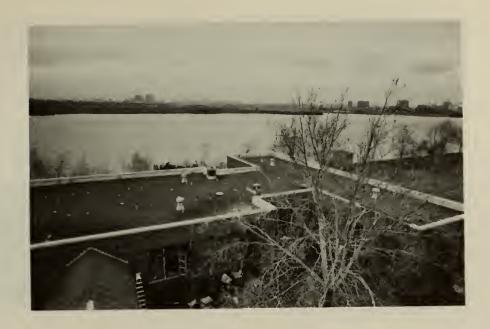
9. Roof, northern half.

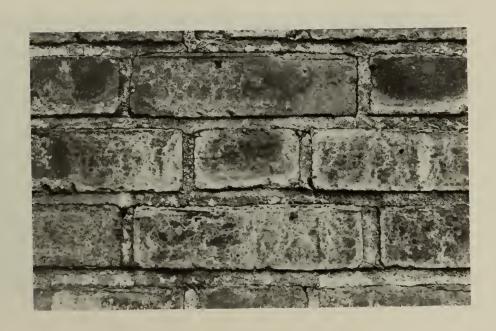
As with the ferry house, brick surfaces of the immigrant building suffer from areas of fairly extensive general detachment and flaking loss of surface glaze exposing brick subsurfaces. Cracking occurs in one area of the east elevation of the central block. Areas of mortar deterioration and separation of mortar from bricks occur randomly. This appears to be most severe above the window lintel header coursing. Efflorescence occurs on all elevations (photo 10).

10. Efflorescence, north facade.

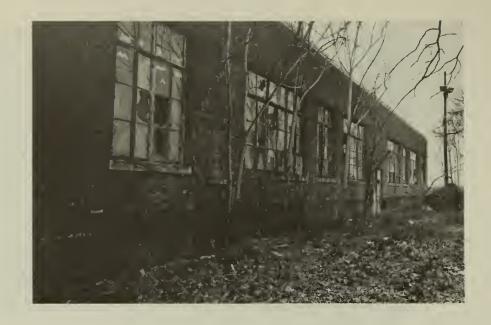
11. Broken window, north facade.

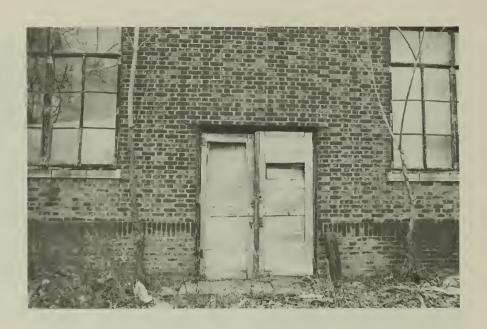
12. Wood doors, north facade.

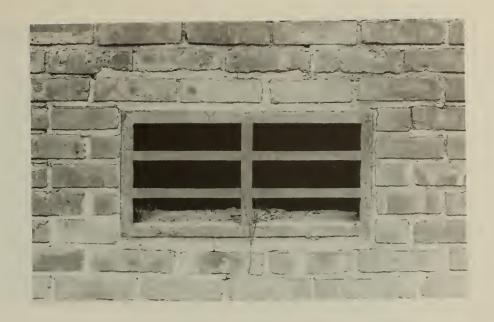
13. Metal grille, east facade.

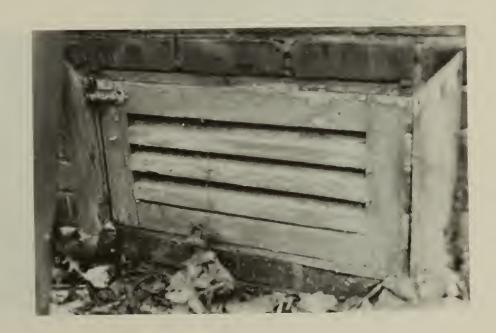
14. Wood grille, east facado.

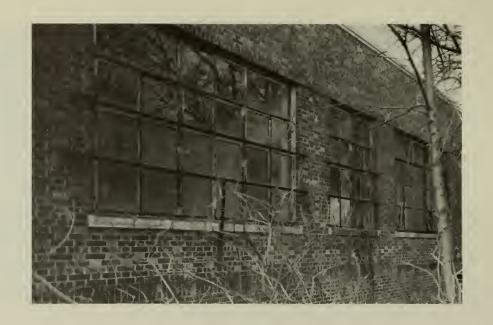
Terra cotta surfaces exhibit general erosion through weathering with some chipping and random areas of as in a portion of a window sill face on the elevation. Iron staining occurs in patches on most terra cotta sill surfaces with carbon staining appearing in mortar joints and on upper surfaces of window sills (see photo 4). staining as well as areas of dark water staining appears on most elevations, occurring primarily below the window sill level. Steel window sash and frames exhibit general surface pitting and rusting, and display remnants of cream, aluminum and turquoise colored overpaint, now rust stained and generally lifting. Window glass suffers from general to random areas of cracking, breakage and loss (photo 11). Metal doors on the east, west and south elevations exhibit rusting of metal surfaces resulting in some loss (see photo 6). The original metal french doors of the north elevation of the north wing have been replaced by two wood paneled doors, which are unlike and are themselves in severely deteriorated condition (photo 12). Metal as well as some wood grilles have been installed below some windows in the brick base with wood grilles exhibiting some deterioration and loss (photos Various surface alterations are visible on most elevations such as the attachment of wood and metal fasteners and bars to brick surfaces. Metal bars have been bolted to the face of the brick across two window openings on the south elevation (photo 15).

15. Windows with bars, south facade.

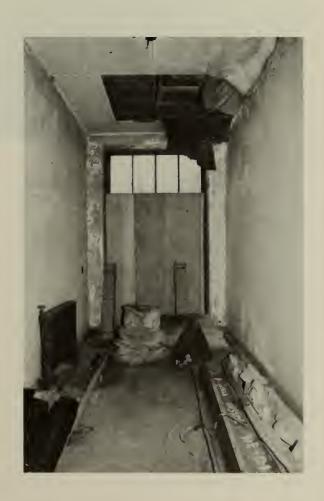
cannot be accurately assessed. There are some areas of loss of acoustic panels and damage to underlying plaster finishes due to water penetration (photo 27).

27. Water-damaged acoustical ceiling panels, H106.

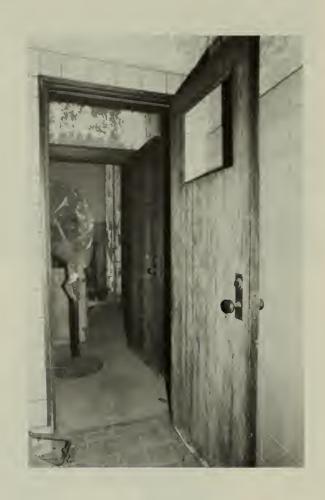
Wood veneer interior doors are in fair condition with some surface staining of lower areas due to water absorption, random loss of metal louvers and some loss of entire door due to removal (photo 28).

28. Door with missing metal louvre.

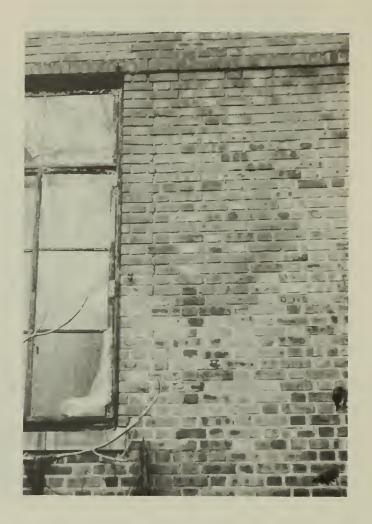
Only one crack was found in the exterior walls. This was vertical and located in the east wall of the north portion of the central block (photo 33).

All structural cracks seem to have been caused by thermal movement. The roof leaks were probably the result of cracks in the roof structure now concealed by the hung ceiling. In general, such cracks are structurally not a problem. However, when upgrading of the building is undertaken, further investigation in the leakage areas should be made. Since the corrosion of the reinforcing bar occurred in a joist completely supported on the bearing wall, no emergency repair appears necessary.

33. Vertical crack, east wall.

There were no deficiencies found requiring any repair of the structure.

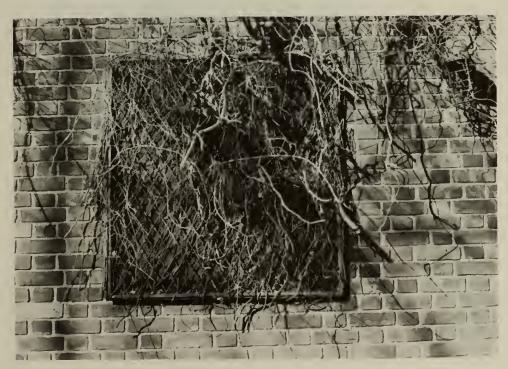
19. Shelter, grille on exterior window face, south room.

A lean-to shed has been constructed against the west elevation of the covered way 9E section of corridor 9 which leads to the staff house. This shed is in a deteriorated state (photo 19).

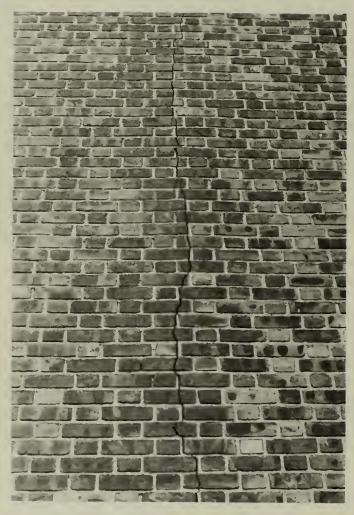
22. Recreation building, cracking east facade.

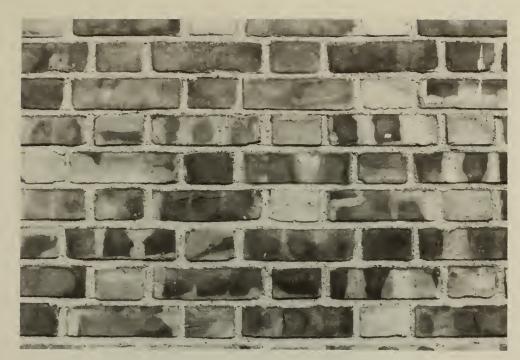
23. Brick flaking.

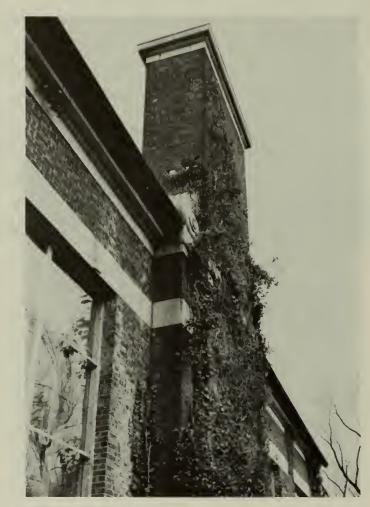
24. Vine-cover, east facade.

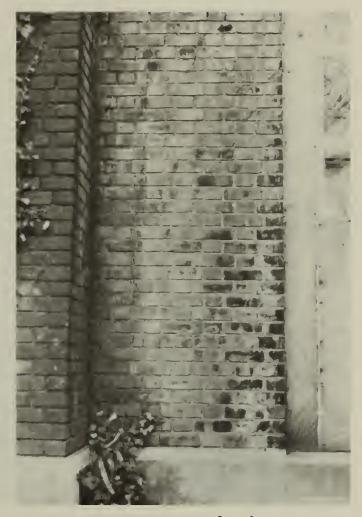
25. Efflorescence, east facade.

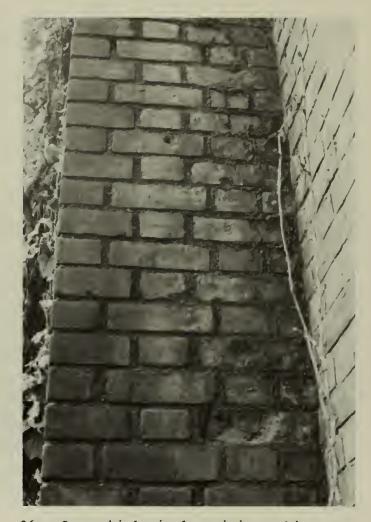
26. Green biological staining, chimney.

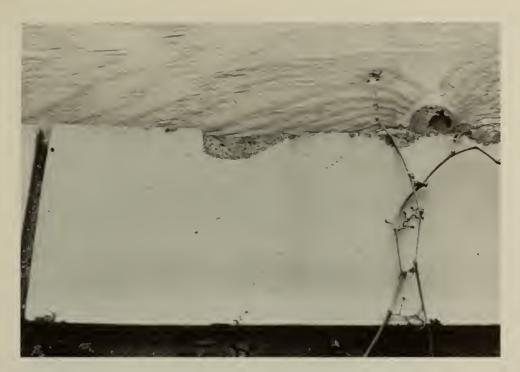
27. Chipping, terra cotta sill, west facade.

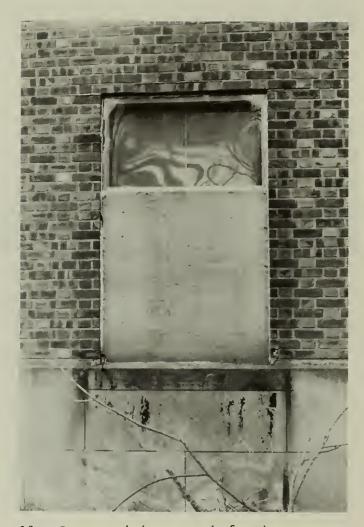
28. Iron staining, north facade.

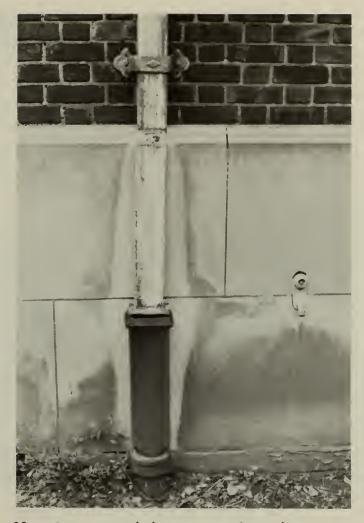
29. Copper staining, east elevation.

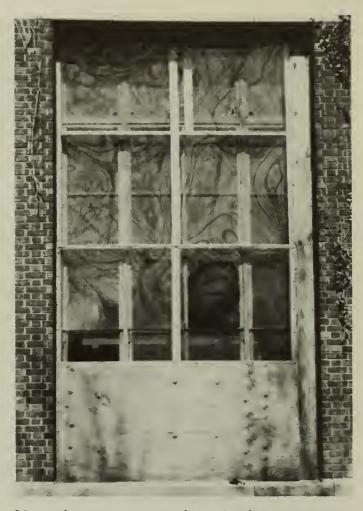
30. Window covered with plexiglass and wood, east facade.

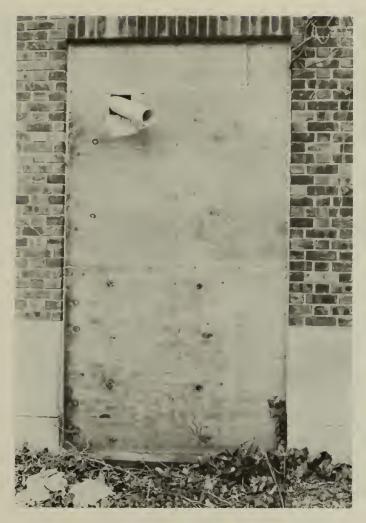
31. Pipe protruding from infilled door, east facade.

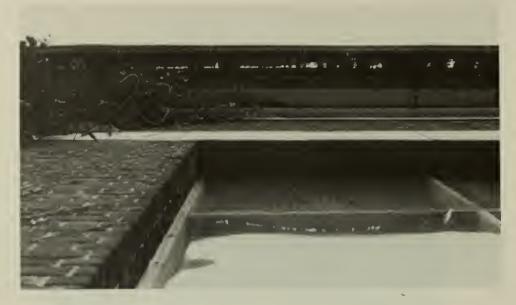
32. Deteriorated gutter.

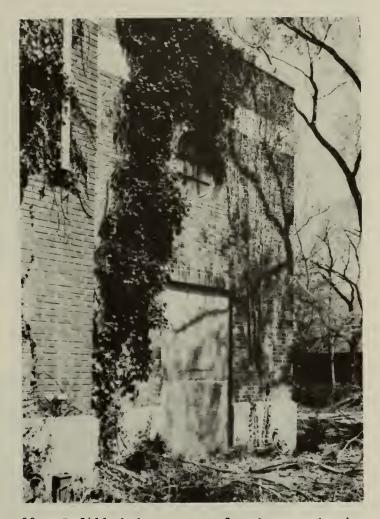
33. Infilled door, east facade, north wing.

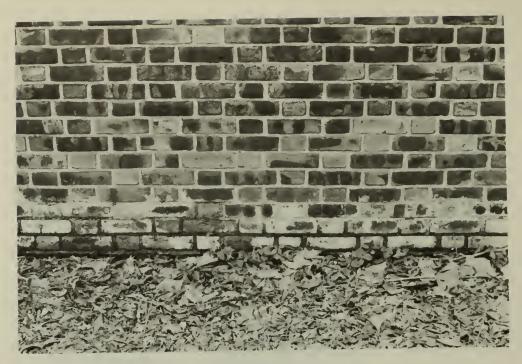
34. Efflorescence, base of shelter wall.

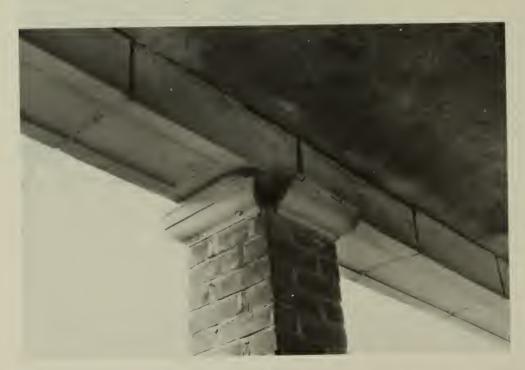
35. Broken terra cotta, shelter.

The only repair necessary to the shelter structure is the cosmetic patching of the terra cotta trim. No other remedial action is required.

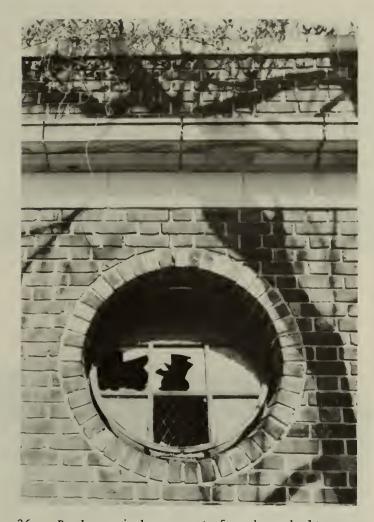
36. Broken window, east facade, shelter.

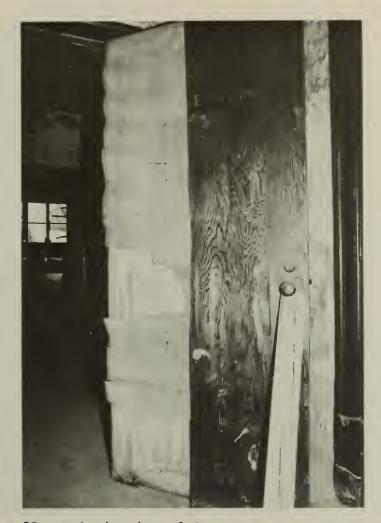
57. Delamination of door.

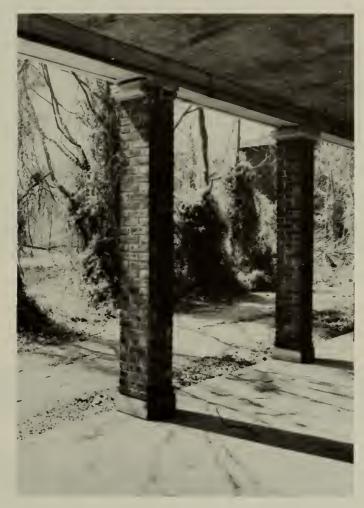
59. Broken terra cotta, shelter.

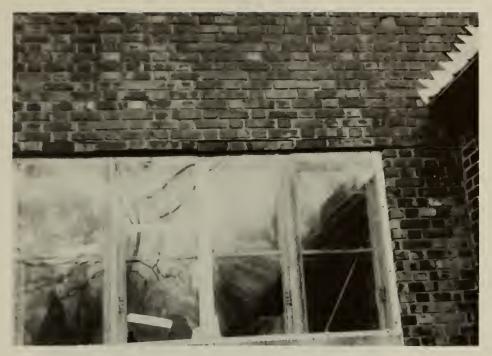
61. Horizontal cracks above lintel, north facade, west link.

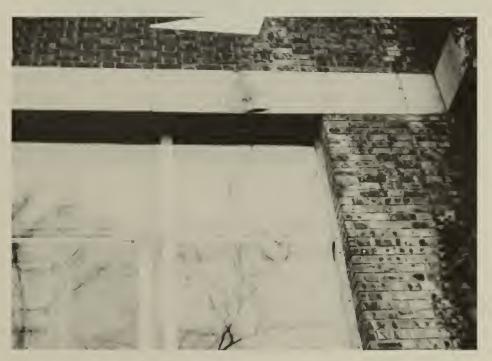
62. Cracked and chipped terra cotta lintel, east facade.

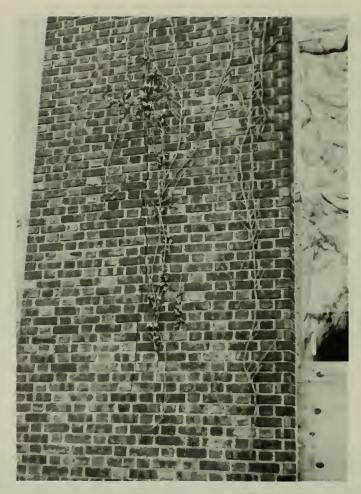
63. Cracking, east facade, north end.

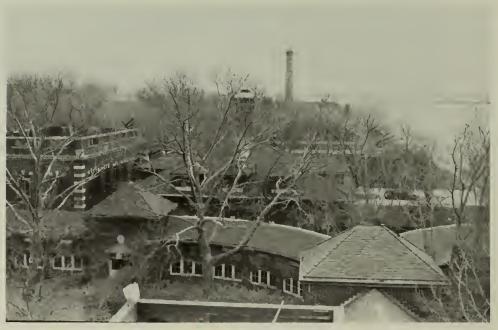
7. C-8, view from roof of ferry house.

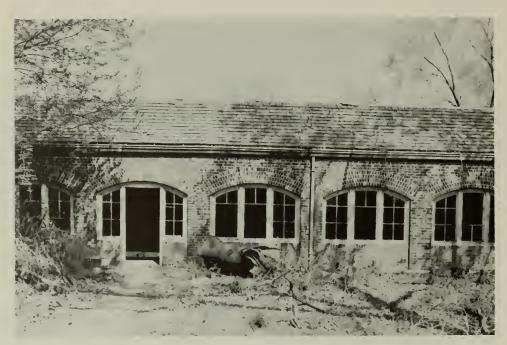
15. Missing sash, east elevation, C-8C.

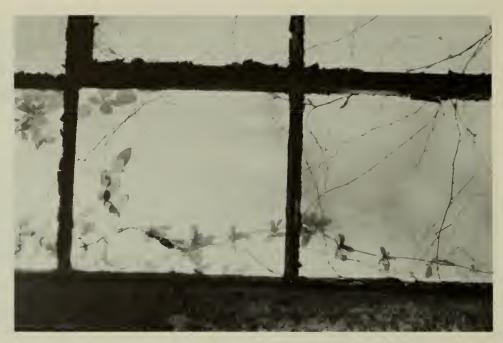
18. Corroded metal sash, C-9D.

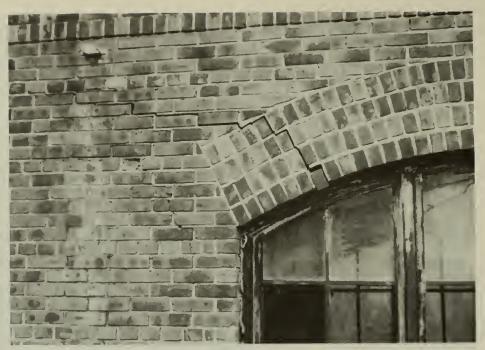
25. Cracking at brick joints, C-7B.

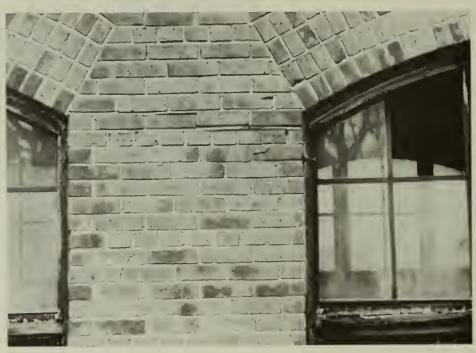
26. Cracking at brick joints, C-7B.

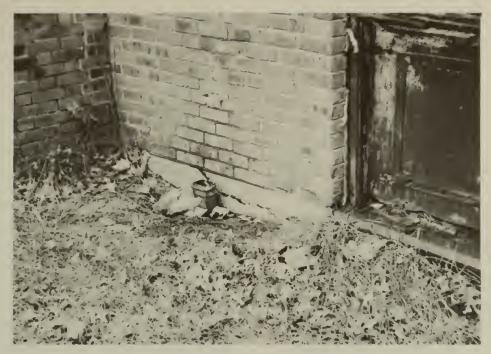
27. Cracking of concrete base, C-7B.

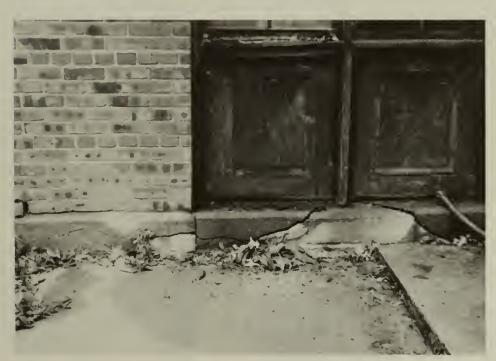
28. Cracking of concrete base, C-7B.

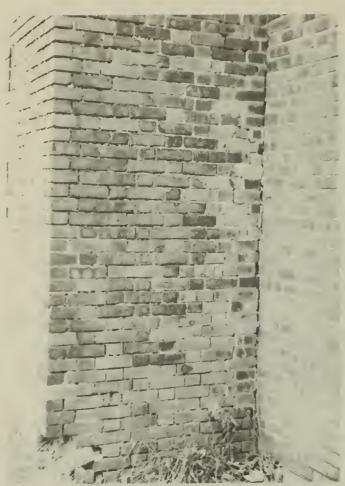
29. Deteriorated brick joints, east wall of south pavilion, C-7A.

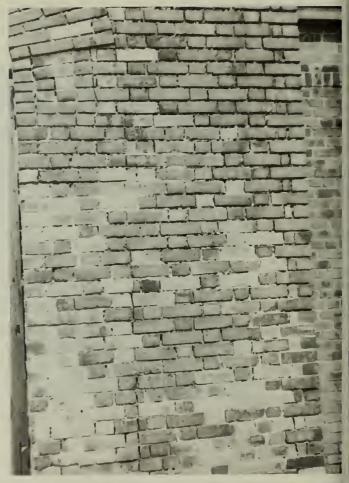
30. Deteriorated brick joints, north wall of south pavilion, C-7A.

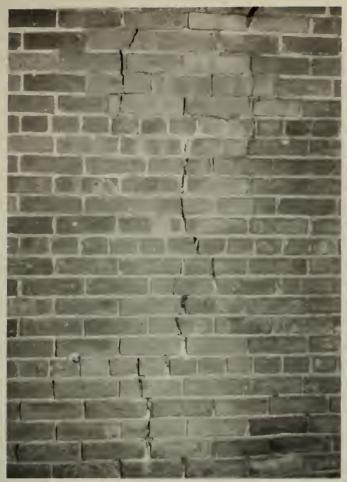
31. Cracks on interior wall of south pavilion, C-7A.

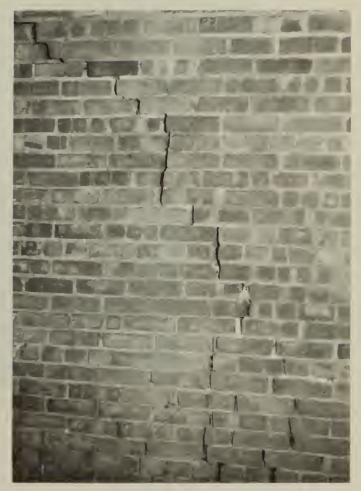
32. Cracks on interior wall of south pavilion, C-7A.

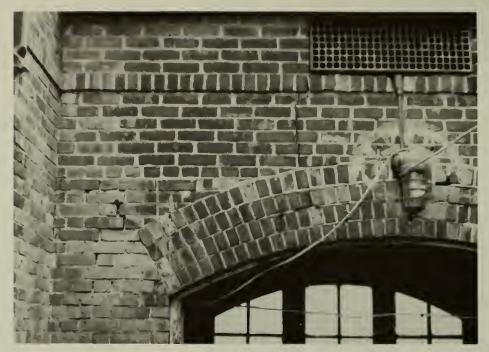
33. Cracks, west elevation of south pavilion, C-7A.

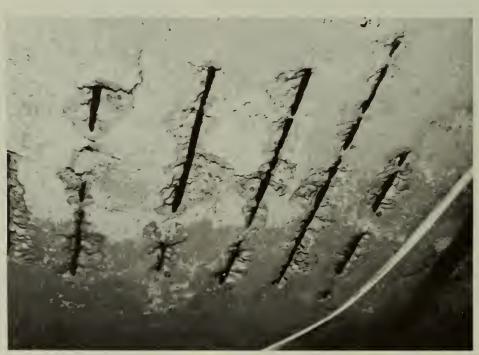
34. Exposed and rusting steel in ceiling slab of north pavilion, C-7A.

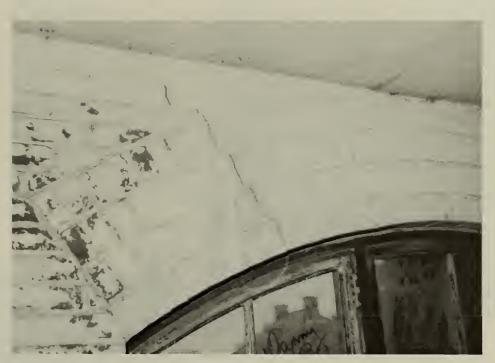
35. Diagonal cracks, north wall of north pavilion, C-7A.

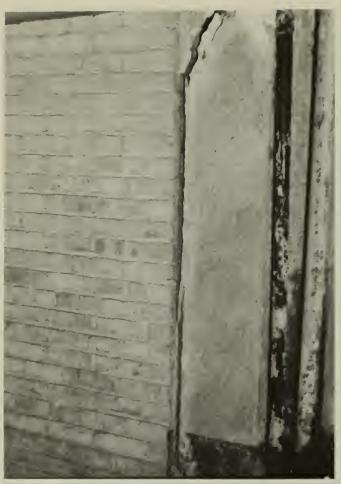
36. Gap at junction between walls of C-8C and C-9A.

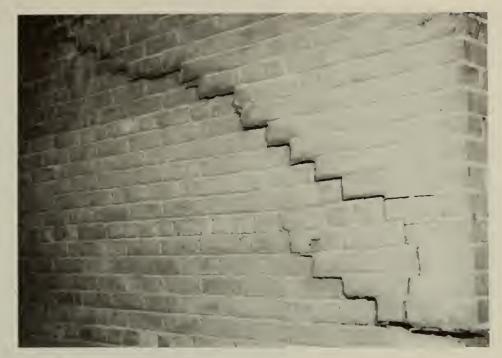
38. Diagonal cracks, east wall, C-8C.

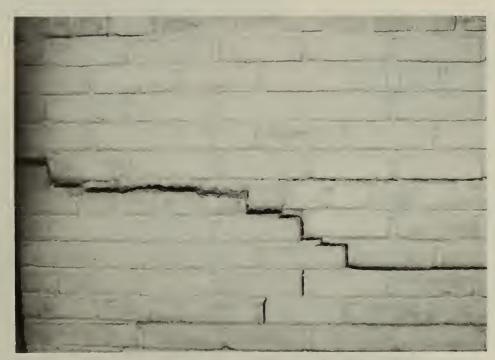
39. Diagonal cracks, north wall, C-8C.

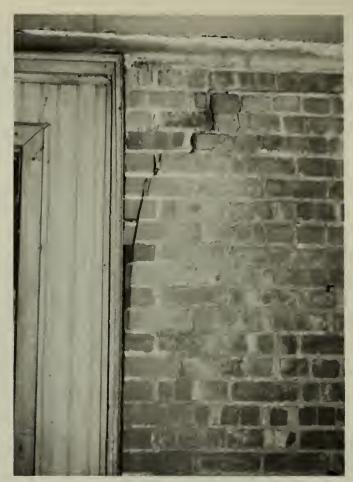
40. Crack, east wall near window, C-8C.

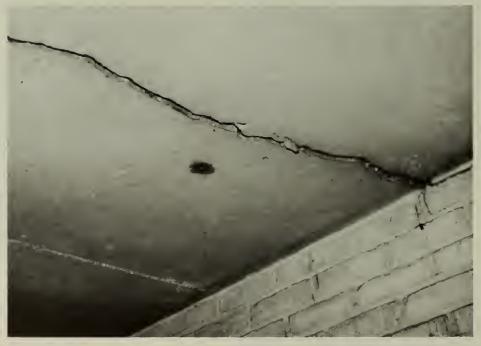
41. Tranverse cracks, ceiling slab, C-8C.

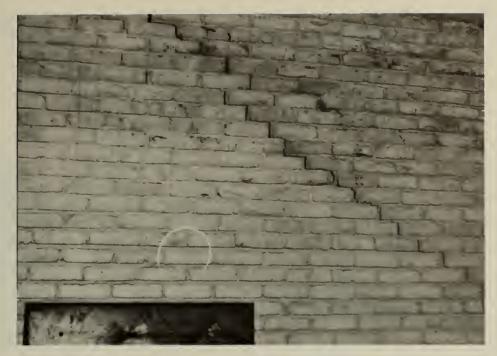
42. Diagonal cracks, south wall, C-8C.

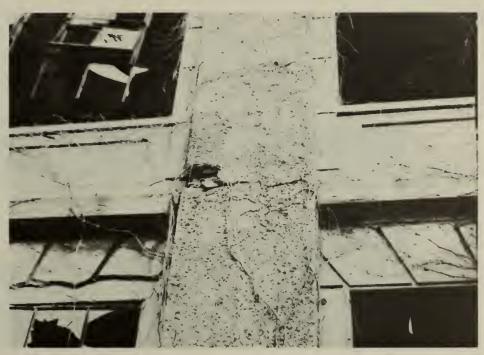
The buckling and cracking of the pier at the second floor of corridor 9C could have been caused by corrosion of steel under the stucco, or possibly is related to expansion and contraction of the walkway. Further investigation is required.

43. Cracking and buckling of pier, south elevation, C-9C.

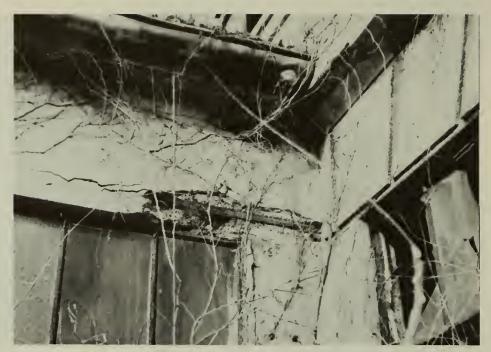
44. Spalled concrete, exposed and corroded beam in east elevation of link to kitchen.

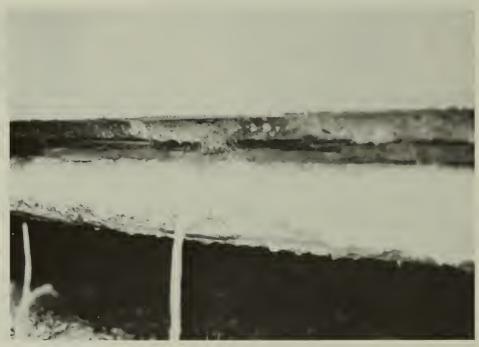
45. Spalled concrete, exposed and corroded beam at base of west elevation of link to kitchen.

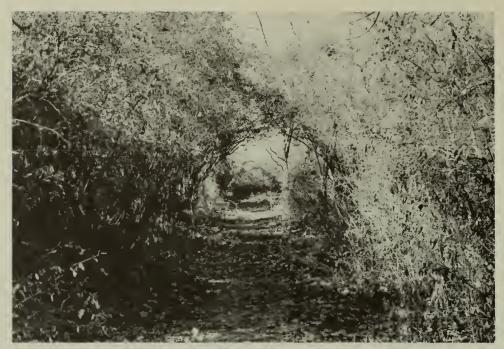
7. Overgrown path between Island 2 and 3.

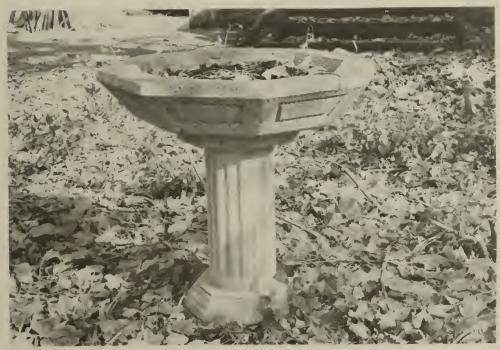
10. Bird bath at rear of Island 2 administration building.
